5 SUSQUEHANNA RIVER BASIN,
2 BLACK CREEK INTAKE DAM
3 PINE GROVE WATER WORKS,

4 (NDI NO. PA-00695,
DER NO. 54-078)

7 PHASE I INSPECTION REPORT.
NATIONAL DAM INSPECTION PROGRAM.

BLACK CREEK INTAKE DAM NDI NO. PA-00695 DER NO. 54-078

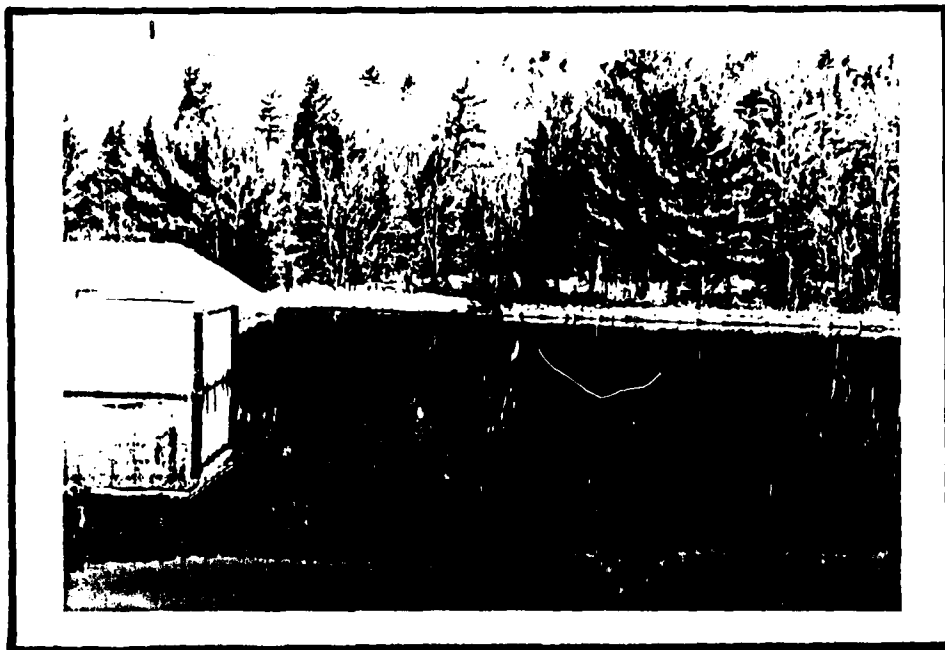
OVERVIEW OF SPILLWAY AND OVERFLOW SECTION - NO. 4

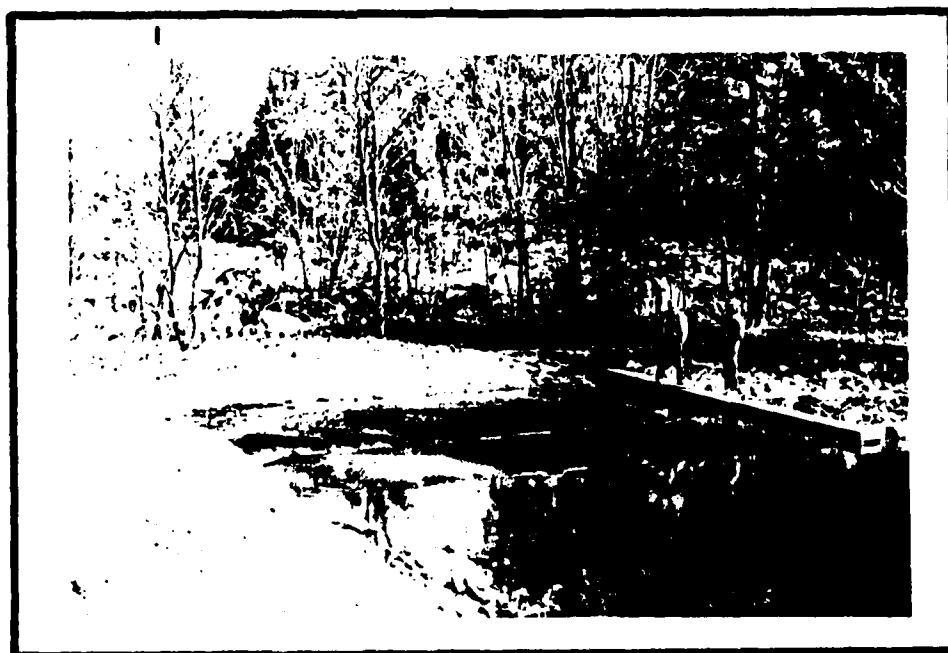
SPILLWAY FOREBAY - NO. 5
NOTE: BOULDER FIELD IN BACKGROUND

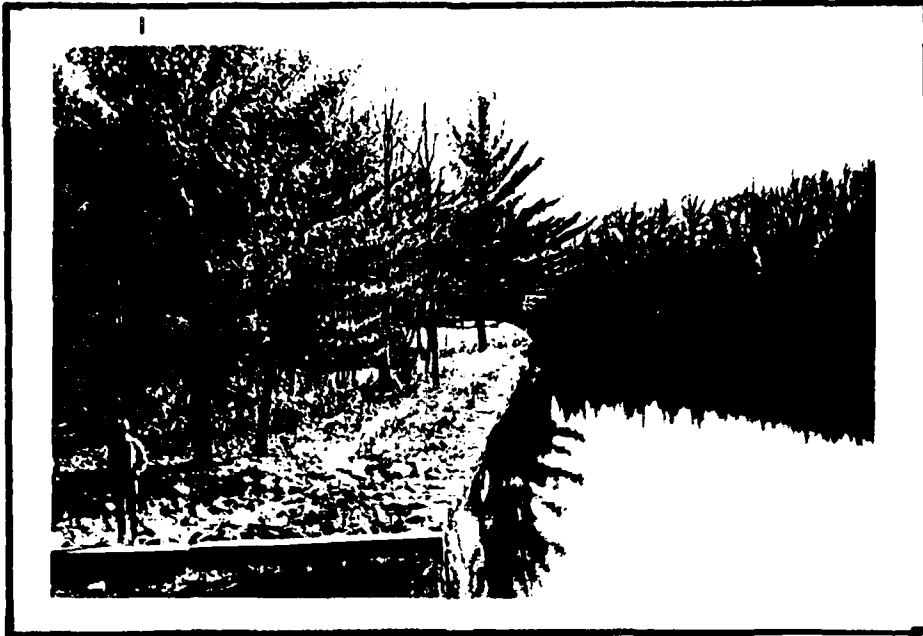
OVERFLOW SECTION - SPILLWAY IN FOREGROUND - NO. 6

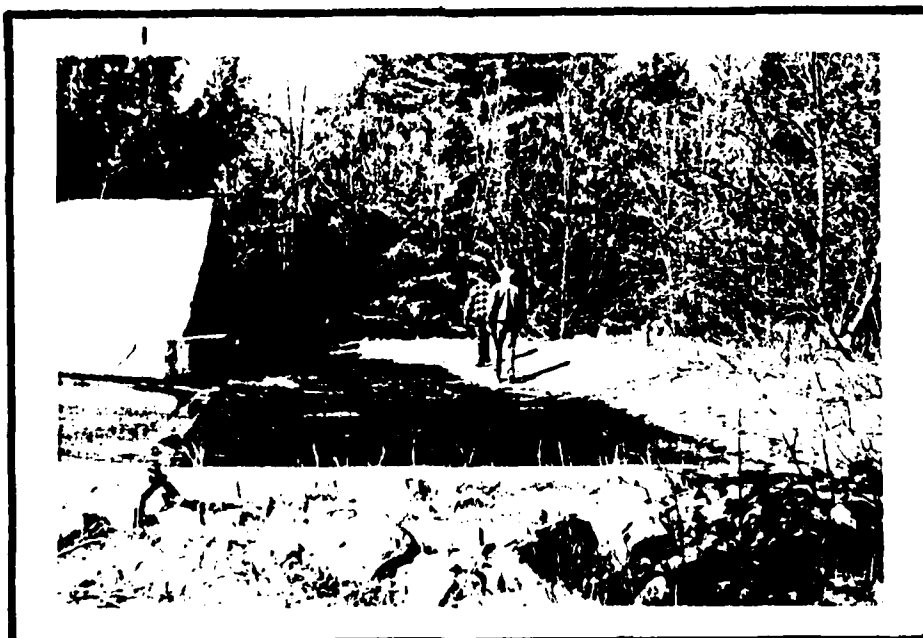
SPILLWAY DISCHARGE AT END OF DAM - NO. 7

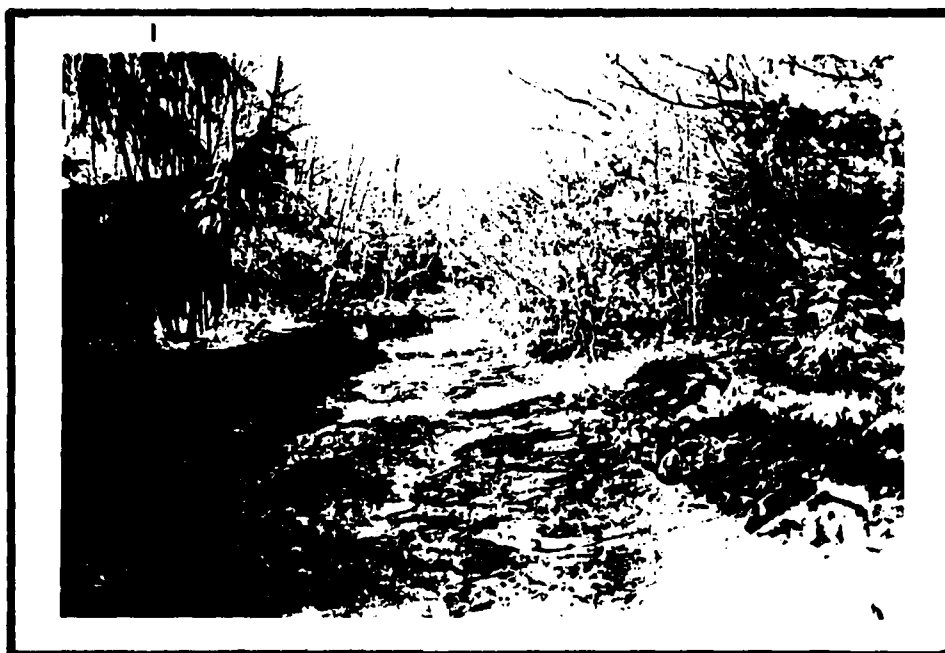
SPILLWAY CHANNEL AND PLUNGE POOL - NO. 9

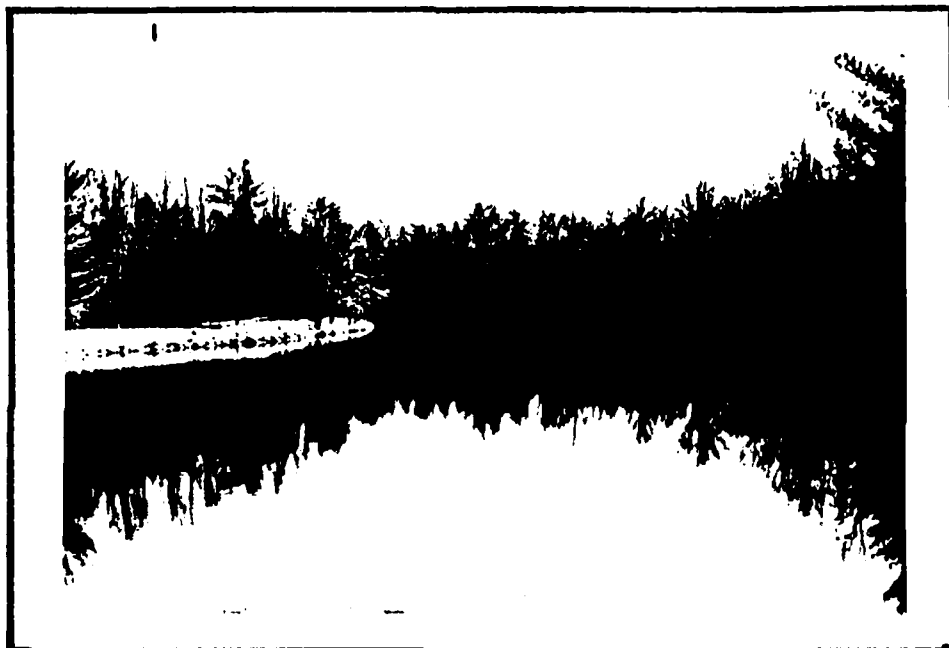
RESERVOIR AREA - NO. 10
